# 1953 Buick Skylark Restoration

## 1953 Buick Skylark Convertible

- **Owner:** Fred Zwicker - Canfield, Ohio
- **Model:** 1953 Buick Skylark
- **Engine:** Original 322 cu in (5.3 L) Fireball V8
- **Transmission:** Twin-Turbine Dynaflow
- **Paint Color:** Majestic White
- **Restoration:** By TP Tools Team using tools and body shop supplies in this catalog
- **Paint:** By Matt Willoughby using TP Tools HVLP Turbine Paint Spray System

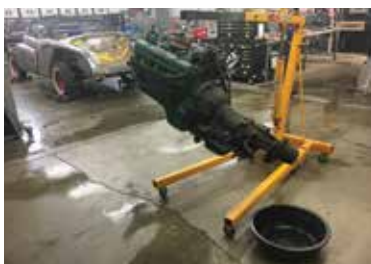
**Engine Removal** - Our first step was to remove the Buick 322 CID V8 engine and transmission. Off to the rebuilders both of them went. When returned, the 322 purrs like a kitten.

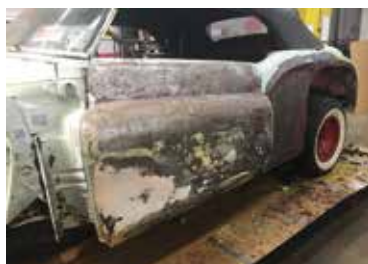
**Paint Stripping** - The '53 had only one repaint, so we decided to strip the entire body to bare metal. Stripping is a big task but we wanted to reveal any original lead or body work under the paint.

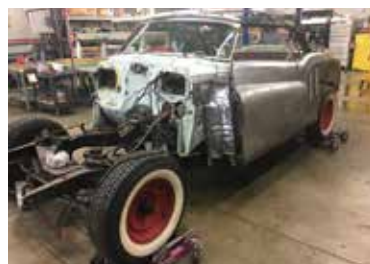
**Panel Prepping** - After stripping the body and panels, we cleaned off all surfaces with a maroon scuff pad and lacquer thinner. The entire car was wiped down again and tack ragged.

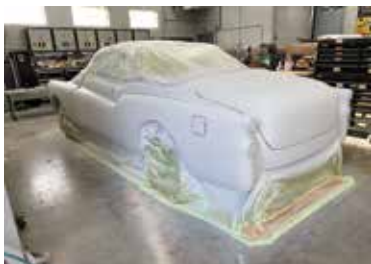
**Primer Applications** - Our TP-99PLUS HVLP Turbine Paint System applied TP Tools® Self-Etch Primer (1K) to seal the metal. Next, TP Tools® Epoxy Primer (2K) was applied over the self-etch primer.

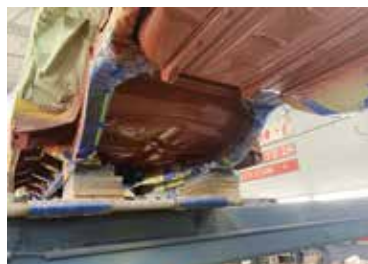
**Undercarriage** - The '53 was well preserved by a heavy coat of undercoating, but took over 400 hours to strip, grind, and wire brush off. The Stripper Air-Operated Removal Tool aided in the removal.

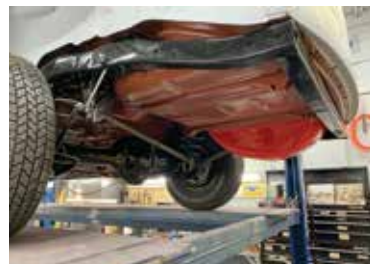
**Undercarriage Painting** - Again, our HVLP Turbine Paint Spray System worked flawlessly. We applied a red oxide primer to the floorboards and a urethane black paint (2K) to the frame rails.

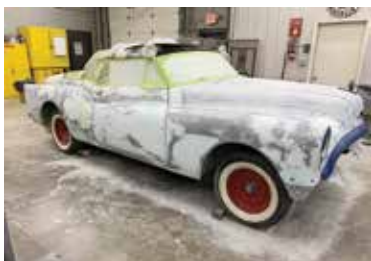
**Body Work/Sanding** - The TP Tools® Epoxy Primer was dry sanded with 180 grit sandpaper and body filler was applied. The epoxy primer provides the best adhesion for body filler & corrosion protection.

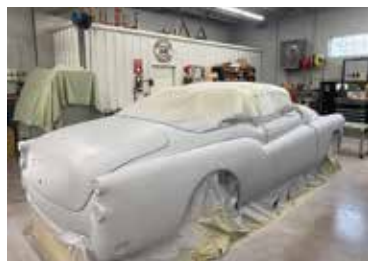
**Polyester Primer** - Prior to applying, the car was dry sanded with 180 grit sandpaper and tack ragged. Then TP Tools® Polyester Filler Primer (2K) was applied to the entire car to level imperfections.

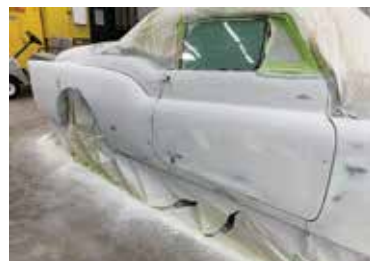
**Block Sanding** - The polyester primer was dry block sanded using a Dura-Block® Sanding Block with 180 grit sandpaper. The polyester primer is a thick sprayable body filler used for filling and leveling.

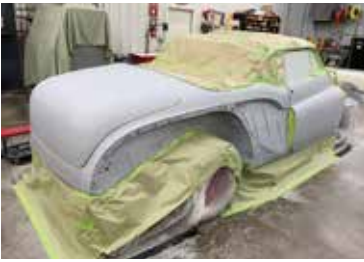
**Urethane Primer** - TP Tools® "3-IN-1" Urethane Primer (2K) was applied over the sanded polyester primer. We then wet sanded the body with a soft sanding block and 320 grit wet sandpaper.

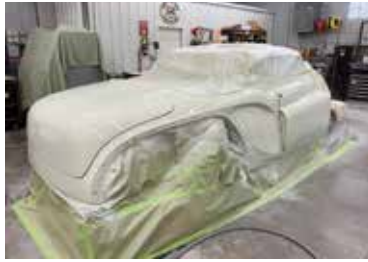
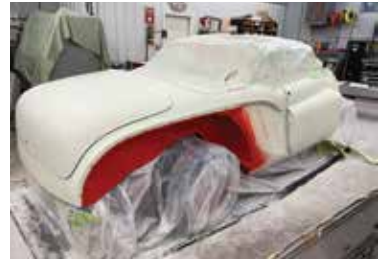
**Final Sanding & Painting** - Our final step prior to painting was to wet sand the '53 with 600 grit paper. We then wiped down the car with TP Tools® Final Wipe Solvent and tack ragged. Our single-stage urethane topcoat (2K) was then applied with the TP Tools® HVLV Paint Spray System. Four coats were applied to allow for sanding and buffing. After buffing, the finished Skylark is ready for the Buick National Meet. *Beautiful!*
